page		page
<b>CLIMATE CONTROL</b>			
- Introduction	1	- Problems of a mechanical nature	42
- Diagram showing operation of manually operated heating system	5	- Problems of an electrical nature	43

Climate control or the variation of the temperature and the humidity of the air in the passenger compartment can be achieved by one of the following two systems:

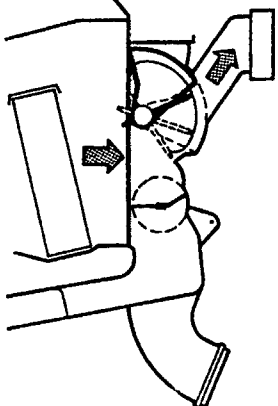
<p>Distribution flaps upwards</p> <p>Air conveyed to the centre and side vents</p>	<p>With air adjusted to ambient temperature or minimum for summer ventilation</p>

The table below illustrates for both systems the possible positions of the distribution flaps and the flaps adjusting the flow of air to the footwell vents and the corresponding distributions of air and conditions are described.

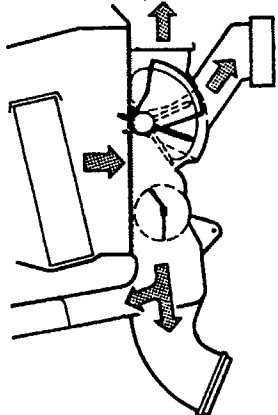
<p>Distribution flaps in middle position</p> <p>Air conveyed to all the vents, mainly to the footwell vents</p>	<p>Condition with temperature adjusted to maximum with considerable heating suitable for winter-time</p>

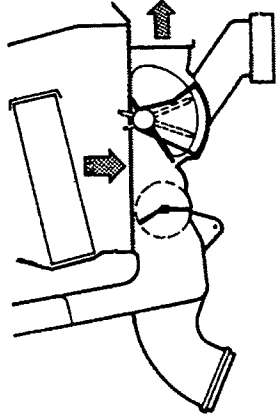
<p>Distribution flaps downwards</p> <p>Air distributed to wind-screen vents</p>	<p>Used when front windows need de-misting or de-frosting rapidly</p>

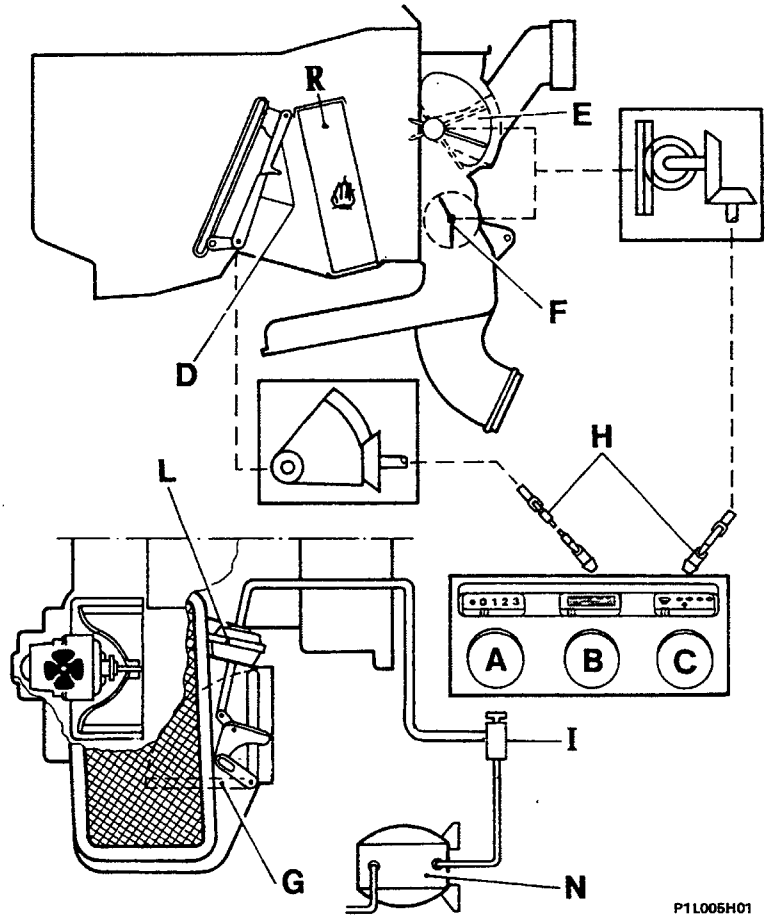
- A. Knob controlling intake and adjustment of air flow rate.
- B. Temperature adjustment knob.
- C. Distribution selector knob.
- D. Mixture flaps.
- E. Distribution flaps.
- F. Footwell air vents adjustment flap.
- G. Air intake flap.
- H. Shafts with universal joints.
- I. Vacuum switch.
- L. Air intake flap (G) control actuator.
- N. Vacuum reservoir.
- R. Heater

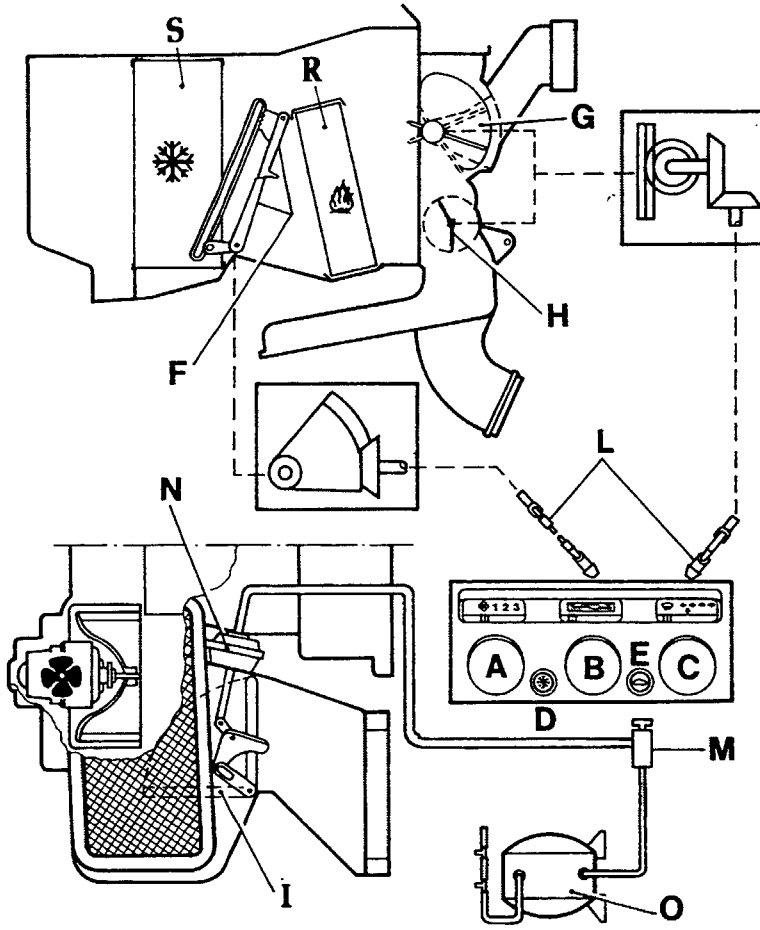
DIAGRAM SHOWING OPERATION OF MANUALLY OPERATED CLIMATE CONTROL SYSTEM

Diagram showing manually operated climate control system

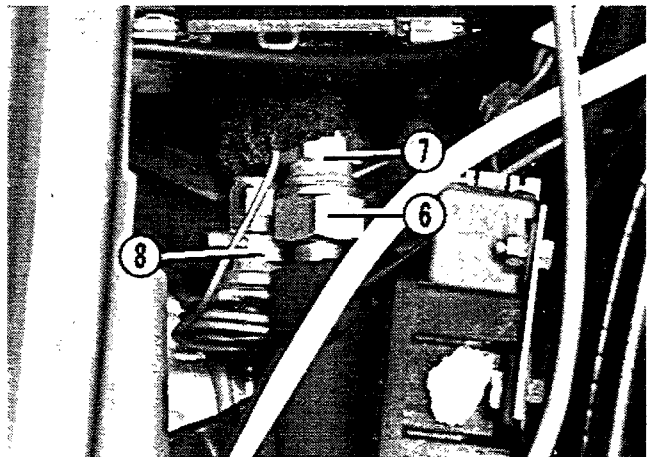
P1L011H03

- drain the air conditioning system (as far as the operations are concerned see the description and illustration on page 23);
- undo the union (6) and the one below (not visible in the diagram) for the pipes which are connected to the outlet duct (7) for the evaporator and to the expansion valve (8);

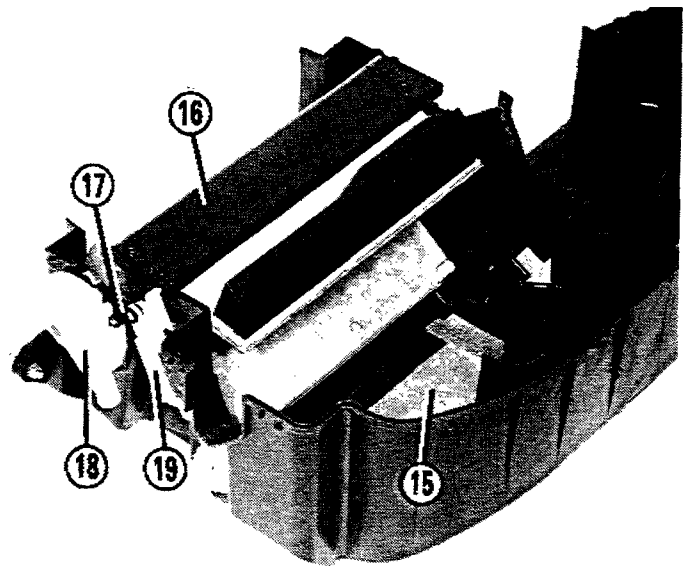
P1L015H02

- remove the lower plate (15) supporting the evaporator;
- remove the shield (16) (positioned above the heater) whose lower projections fit in the openings in the casing (shown by the arrows in the diagram at the top of the next page);
- stretch the end section of the tap (18) control lever (17) to release it from the operating rod (19);
- remove the heater (20) from its housing in the casing.

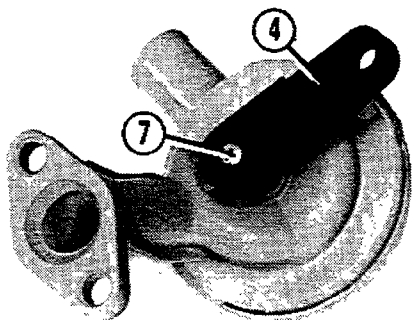
P1L022H03

- after having drained the engine cooling system loosen the band (1) and detach the pipe (2) from the tap (3) inlet duct;
- suitably expand the end section of the lever (4) so that it can be released from the rack rod (5);
- undo the nuts (6) which fix the tap (3) to the heater and undo the bolt (7) which fixes the lever (4) in position on the shaft.

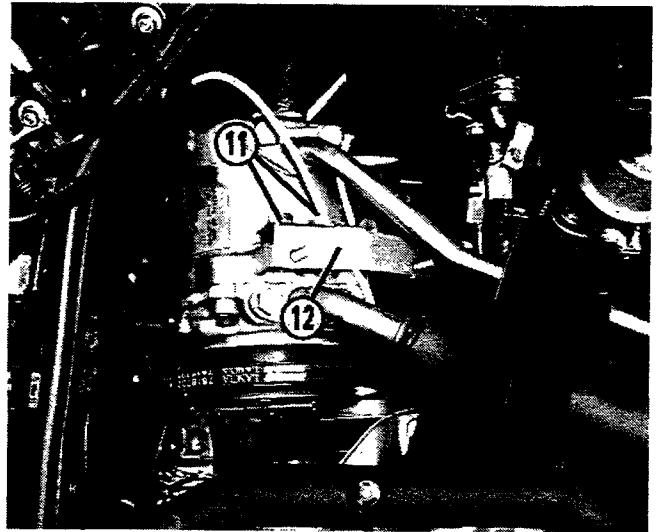
P1L025H01

- undo the bolts (11) which fix the plate (12), supporting the shield (10) and the connecting bar (13) to the compressor at the top and undo the fixing bolt;
- loosen the bolt (14) which fixes belt tensioner support (16) to the front bracket (15) mounted on the power assisted steering pump;
- suitably position the belt tensioner (16) and release the belt (17) which transmits the power from the power assisted steering pump to the compressor from the appropriate pulleys;
- disconnect the electrical connection for the supply cable for the compressor pulley electro-magnet coupling;
- undo the bolts (18) which fix the compressor at the bottom to the mounting brackets (15 and 19) anchored to the power assisted steering pump.

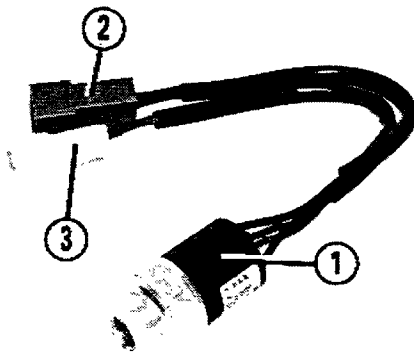
P1L032H02

The air conditioning system does not have to be drained in order to remove the three stage pressure switch (1), simply undo it from the pipe which connects the condenser to the drier filter after having disconnected the two electrical connections (2 and 3) for the cables.

The three stage pressure switch has the task of activating the supply circuit for the electric fan for cooling the engine coolant condenser and radiator when the vehicle is stationary or in slow moving traffic and the flow of air created when the vehicle moves forwards starts to fail and the condensation of the coolant fluid is required through ventilation.

In addition the three stage pressure switch has the function of interrupting the supply circuit for the compressor pulley electro-magnet coupling when the pressure of the coolant fluid (high pressure side) reaches dangerous limits in spite of the action of the electric fan or because of its failure to operate or when on account of a leak or because the outside temperature is below 10°C (thermal conditions insufficient to cause the evaporation of the coolant fluid) the pressure of the coolant fluid reaches a value below 1.96 bar.

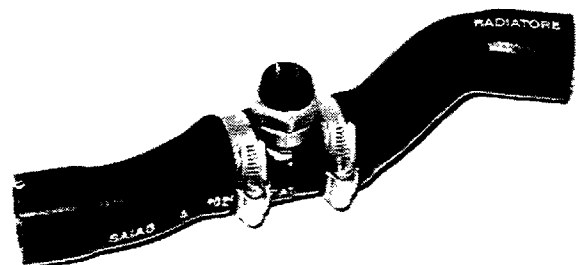
P1L032H04

To replace the switch, which is available as spares with the union onto which it is bolted and the two hoses, simply release the switch from the engine and radiator ducts after having loosened the retaining bands and released the two connectors (3) for the supply cables from the upper terminals.

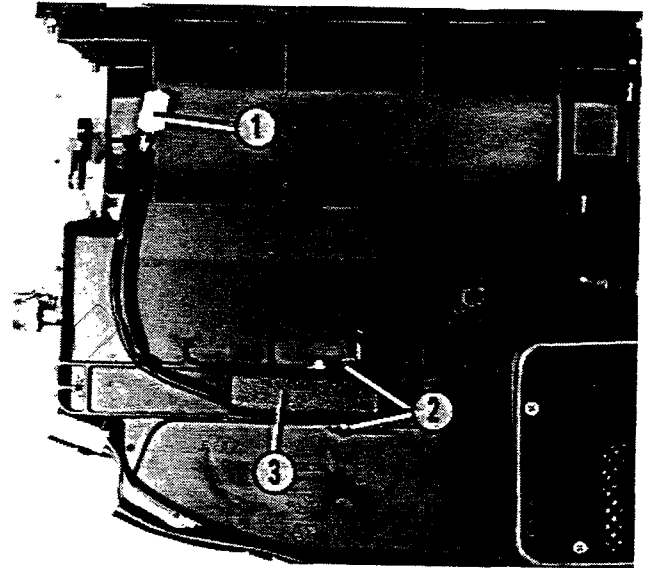
P1L033H01

- disconnect the electrical connection (1) for the cables connected to the anti-frost thermostat;
- undo the bolts (2) which fix the anti-frost thermostat (3) to the upper surface of the casing containing the evaporator and the heater;
- vertically raise the anti-frost thermostat (3) until the sensitive bulb (4) is completely removed from the casing.

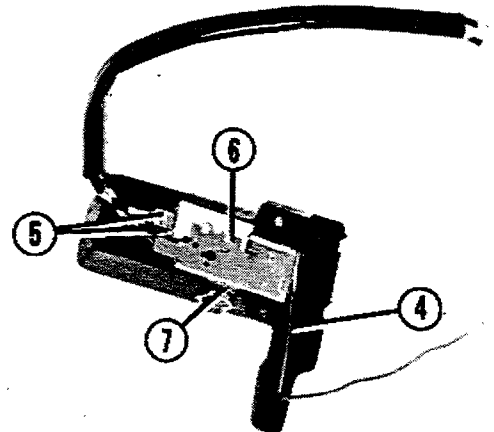
P1L033H02

Detach the two terminals (5) for the cables which are fitted to the terminals for the anti-frost thermostat (6) and loosen the nut (7) fixing the latter to the shield.

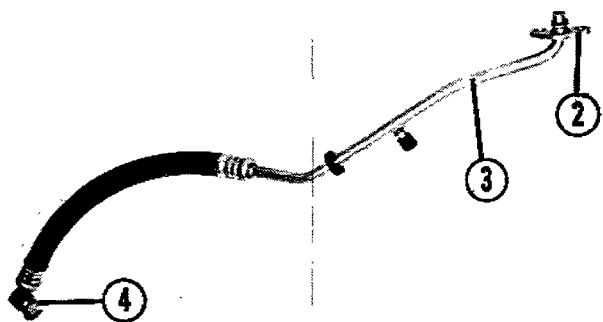
P1L034H02

- undo the two bolts (1) which fix the plate (2), which keeps one end of the pipe (3) in the supply duct, to the compressor;
- undo the union (4) at the other end of the pipe (3) which connects it to the condenser;
- release the rubber ring (5) fitted on the pipe from the mounting bracket (6).

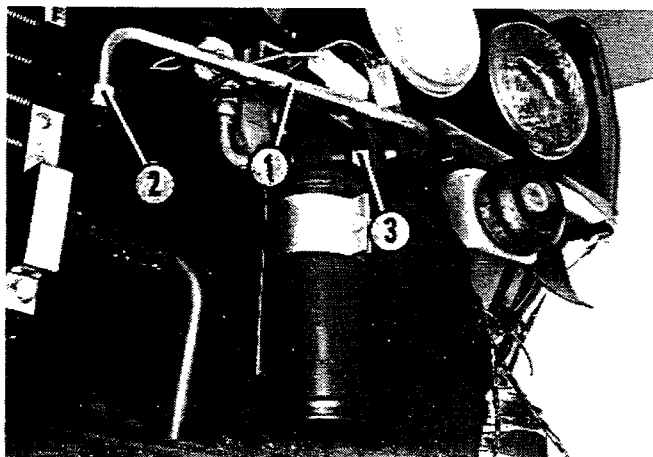
P1L034H03

In order to remove the pipe (1), after draining the air conditioning system, simply undo the unions (2 and 3) which connect it to the condenser and the drier filter.

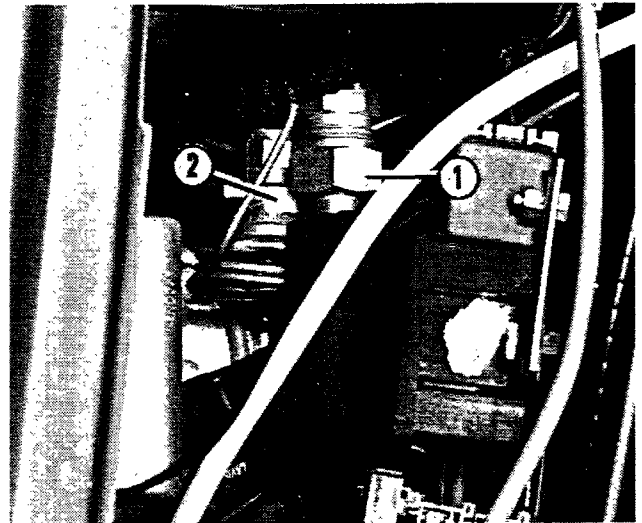
P1L031H01

- undo the union (1) for the pipe connected to the evaporator outlet duct and undo the union for the pipe underneath which is bolted onto the expansion valve (2);

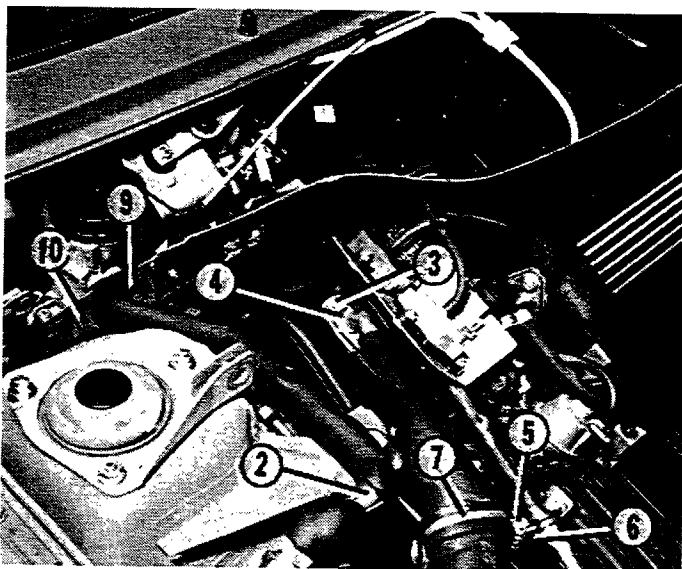
P1L036H02

- undo the union (1) which connects one end of the pipe (2) to the evaporator outlet duct;
- undo the bolts (3) which fix the plate (4) which keeps the other end of the pipe (2) in the compressor inlet duct;
- undo the nut (5) which fixes the plate (7) supporting the pipe (2) to the mounting bracket (6) fixed to the engine;
- remove the right side part of the rubber profile (8) which is fitted on the top of the bulkhead which divides the rear part of the engine compartment from the area under the windscreen from its housing;
- Remove the pipe (2) from the engine compartment after having removed the rubber seal (9) (fitted on the pipe) from the housing in the right metal support (10) for the above mentioned bulkhead.

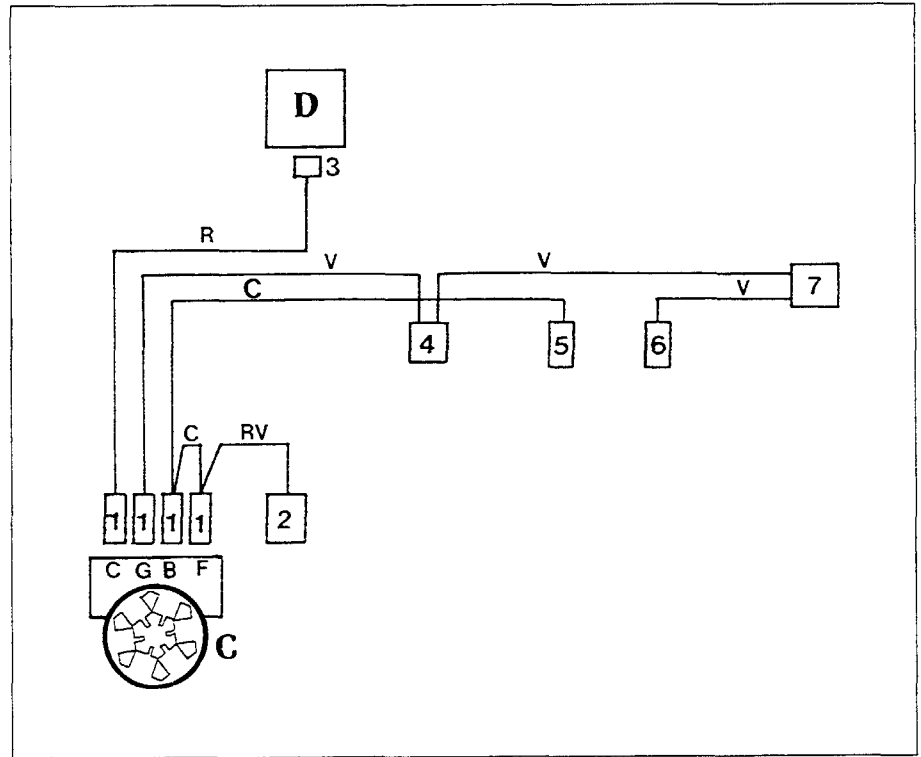
P1L039H01

1. White coloured one way connectors to be fitted to terminals marked with letters for switch for switching on system (compressor)
  2. Red coloured terminal to be connected to red/green cable for hazard warning lights control switch
  3. Female terminal for socket to which relay D is fitted (see previous page) by terminal 85
  4. White coloured two way connector which is connected to anti-frost thermostat cable terminals
  5. White coloured one way connector which is connected to the one for the other wiring
  6. Black coloured one way connector which is connected to the one for the other wiring
  7. Red coloured two way connector which is connected to the red coloured one for the three stage pressure switch cable terminals
- C. Climate control system on switch  
D. Relay for engaging car interior climate control electric fan first speed

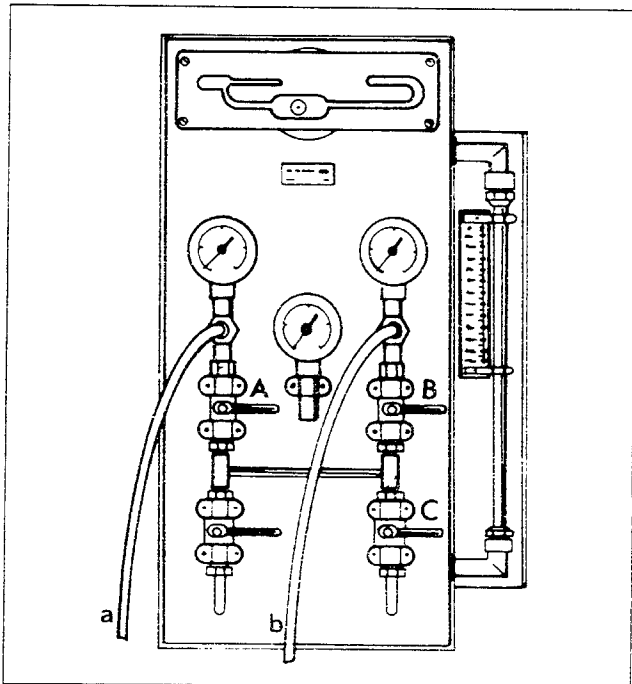
P1L052H02

- check that all the taps for the equipment for the checking, recovery, draining and re-pressurizing of the system in question are closed;
- tighten the union at the end of the light blue coloured low pressure side flexible pipe (a) to the (Bridgeport type) needle valve (1) welded to the pipe which connects the evaporator to the compressor;
- tighten the union at the end of the red coloured high pressure side flexible pipe to the needle valve (2) welded to the pipe which connects the compressor to the condenser;
- take readings from the equipment high and low pressure side gauges (for equipment with the possibility of recovery, first open the taps on the flexible pipes).

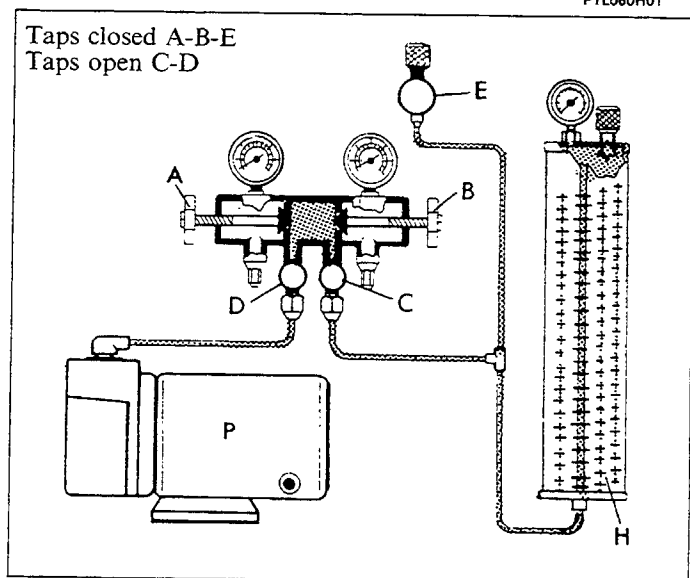
- tighten the unions at the end of the flexible pressurizing pipe (T) one to the outlet union for a canister of coolant fluid and the other (without fully tightening it) to the pressurizing tap (E);
- slightly open the pressurizing canister handwheel to expel the air in the flexible pipe and then lock the union on the tap (E);
- open the pressurizing tap (E) and the pressurizing canister handwheel;

**Diagram showing metering cylinder drainage system**

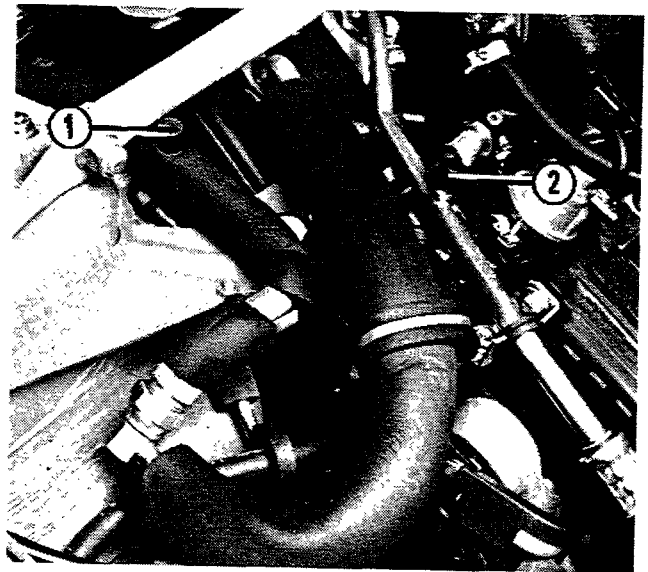
P1L023H01

- the union for the free end of the low pressure side flexible pipe (light blue) should be tightened to the needle valve (1) welded on the pipe which connects the evaporator to the compressor;
- the union for the free end of the high pressure side flexible pipe (red) should be tightened to the needle valve (2) welded on the pipe which connects the compressor to the condenser.

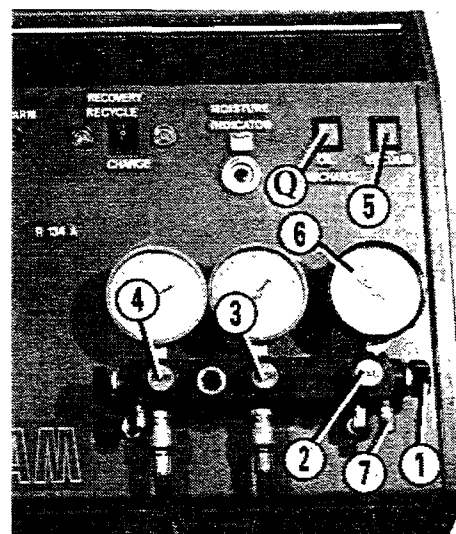
- open the VAC (1 and 2), HIGH (3) and LOW (4) taps and those for the flexible pipes connected to the vehicle system;
- press the button for the VACUUM switch (5) which operates the vacuum pump;
- after about twenty minutes close the VAC tap (2) and stop the operation of the pump by pressing the switch (5) again;
- leave things as they are for 5 minutes and during this period of time check whether the system is water tight by observing whether the value on the vacuum gauge (6) decreases;
- if there are no leaks, start up the vacuum pump again by pressing switch (5) and open the VAC tap (2);

- after about twenty minutes stop the vacuum pump by pressing switch (5) again, close the VAC (1) and LOW (4) taps and then pressurize the vehicle system.

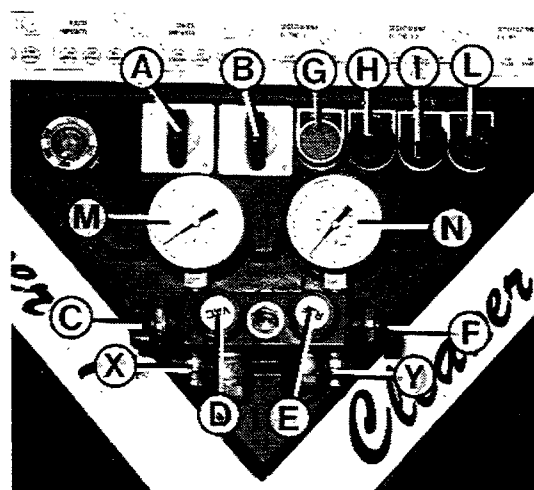
- open the VAC (D), HIGH (F) and LOW (C) taps and the ones for the flexible pipes connected to the vehicle system;
- check that there are no impurities in the vacuum pump and that it contains the recommended amount of oil, then start up the pump by turning the knob for the function selector (A) into position 2 and check that the «PUMP» warning light (H) comes on;
- after about fifteen minutes check the vacuum value reached on the low pressure side gauge (M), then close the VAC tap (D) and turn the knob for the function selector (A) to position 0 and check that the previous vacuum value does not decrease over a period of five minutes;
- if there are no leaks, start up the vacuum pump again by turning the selector knob (A) to position 2 and reopen tap (D);

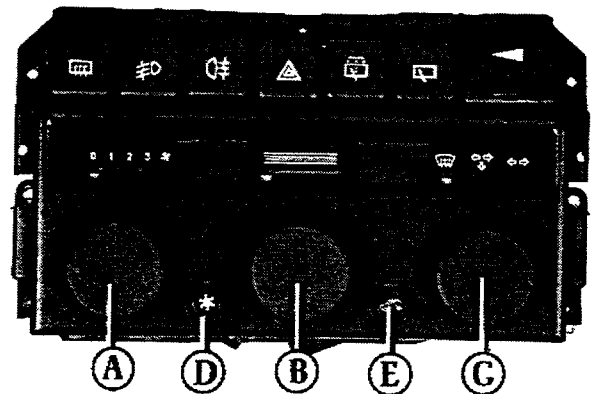
P1L003H02

- connect the terminals for the green coloured cables at the red coloured connector which is fitted to the corresponding terminals for the three stage pressure switch and start up the engine;
- press switch (D) for switching on the compressor;
- turn knob (B) completely in an anti-clockwise direction to the position corresponding to the Blue limit (maximum cold);
- turn knob (A) in a clockwise direction to position 3 corresponding to the maximum fan speed;
- increase the engine rotation speed to 1500 rpm;

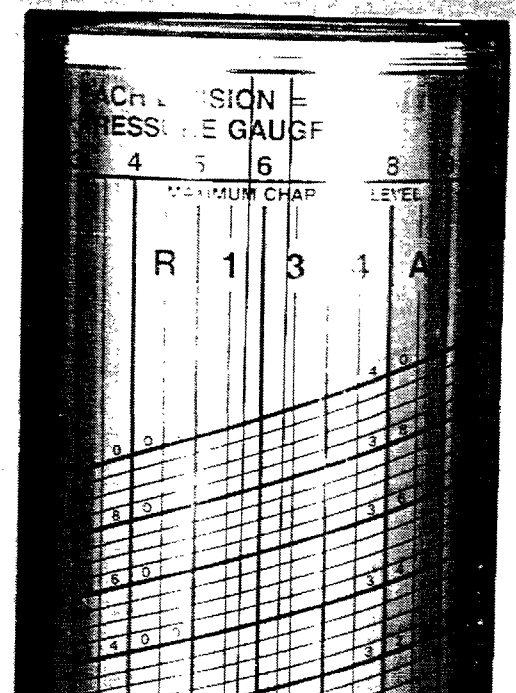
P1L067H01

- keep the connections for the two equipment flexible pipes to the vehicle system valves unchanged;
- align the vertical line corresponding with the value for the pressure measured by the pressure gauge (2 in the diagram at the top of the next page) with the central column for the metering cylinder by rotating the external graduated cylinder (the illustration at the side shows the column with the vertical line corresponding to 6 bar superimposed);
- measure the level reached by the coolant fluid in the column and using the scale on the external graduated cylinder it is possible (by reading the values at the edges of the tilted line) to determine the quantity of fluid contained in the metering cylinder;

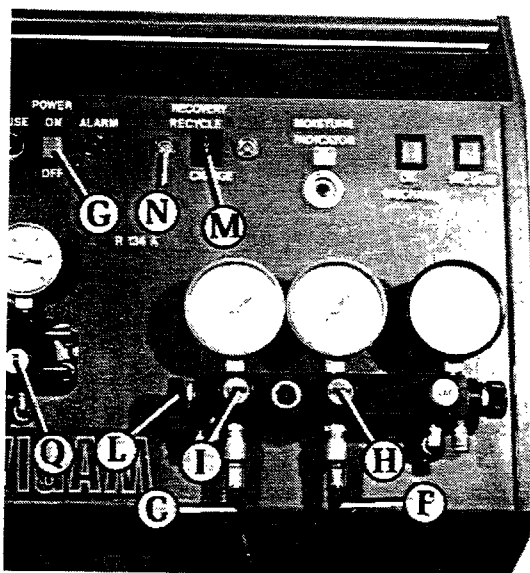
P1L062H03

- start up the engine and activate the climate control system;
- after 10-15 minutes de-activate the climate control system and switch off the engine;
- tighten the unions for the free ends of the equipment flexible pipes to the needle valves welded on the system pipes as described on page 23.

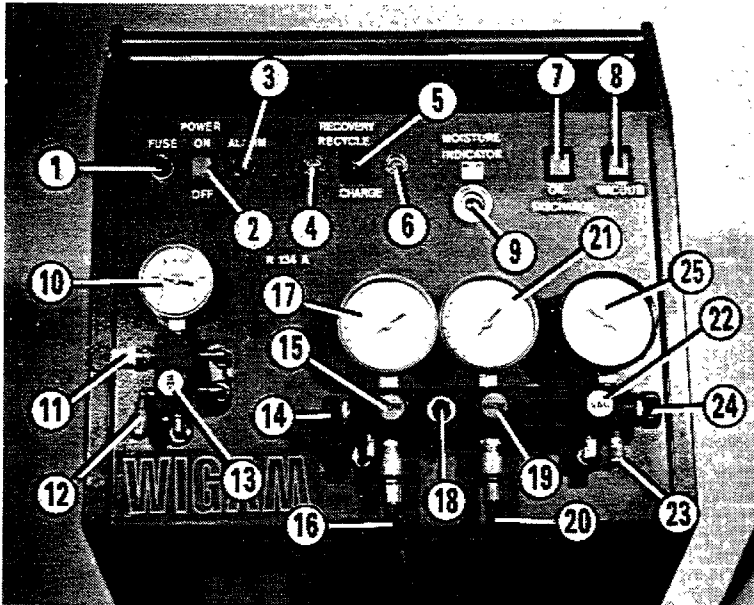
**UP 12 EQUIPMENT (PROCESSING UNIT)**

**View of upper tilted panel**

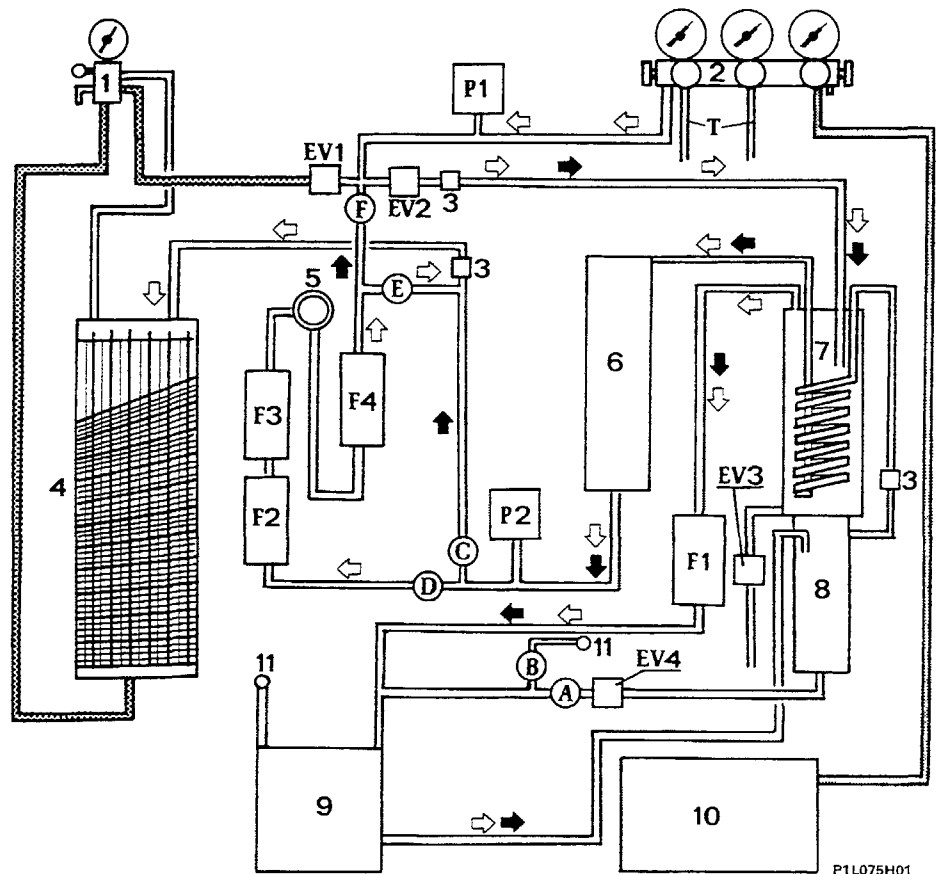
P1L075H01

1. One way pressure gauge
2. Five way pressure gauge
3. Single-acting (one-way) valves
4. Metering cylinder
5. Warning light with humidity indicator
6. Condenser
7. Distiller
8. Oil separator
9. Compressor
10. Vacuum pump
11. Service attachments
- P1. Safety pressure switch
- P2. Supply pressure switch

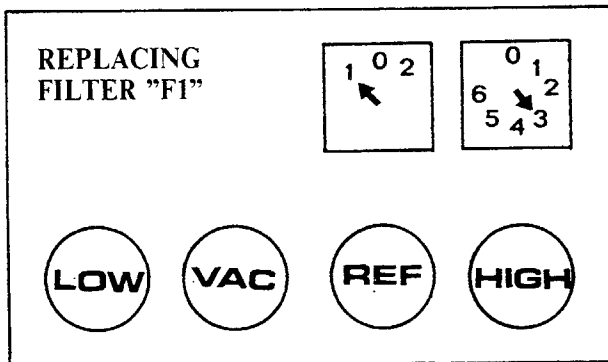
P1L080H01

- return the knobs for switch (B) and selector (A) mentioned above to position 0;
- turn the knob for the general switch to the OFF position;
- remove the left rear panel for the equipment (after having undone the two bolts fixing it at the bottom to the frame);
- undo the nut (4) and remove the mounting bracket (5);
- undo the two unions (6) and replace the filter (1) with a new one taking care that the arrow is facing downwards;
- before retightening the unions (6) on the new filter check that the seals «O-Rings» are fitted and that they are intact and lubricated with vaseline or compressor anti-freeze oil.

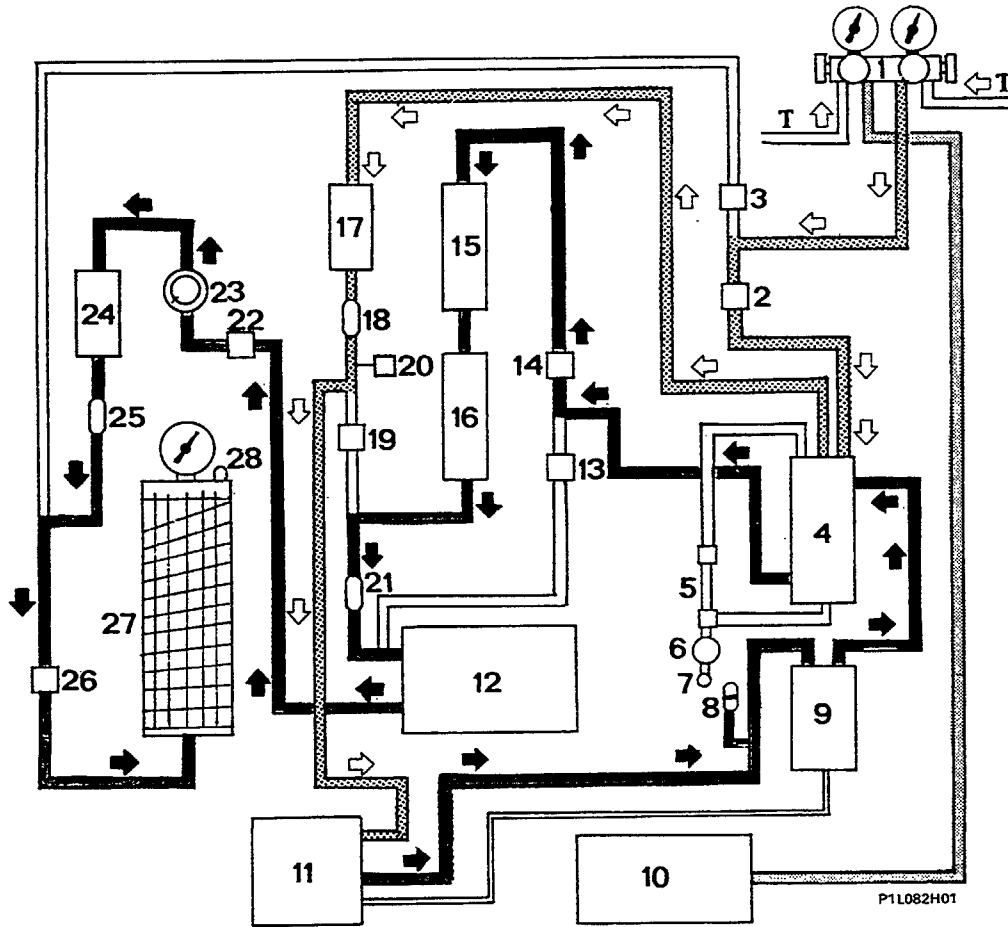
High pressure circuit    
  Low pressure circuit    
  Vacuum circuit
